Characterization of Recent GPS Satellite Clock Jumps

Rebecca Wang*, Yu-Fang Lai*, Juan Blanch*, Dennis Akos**, Eric Phelts*, and Todd Walter*

**Stanford University*

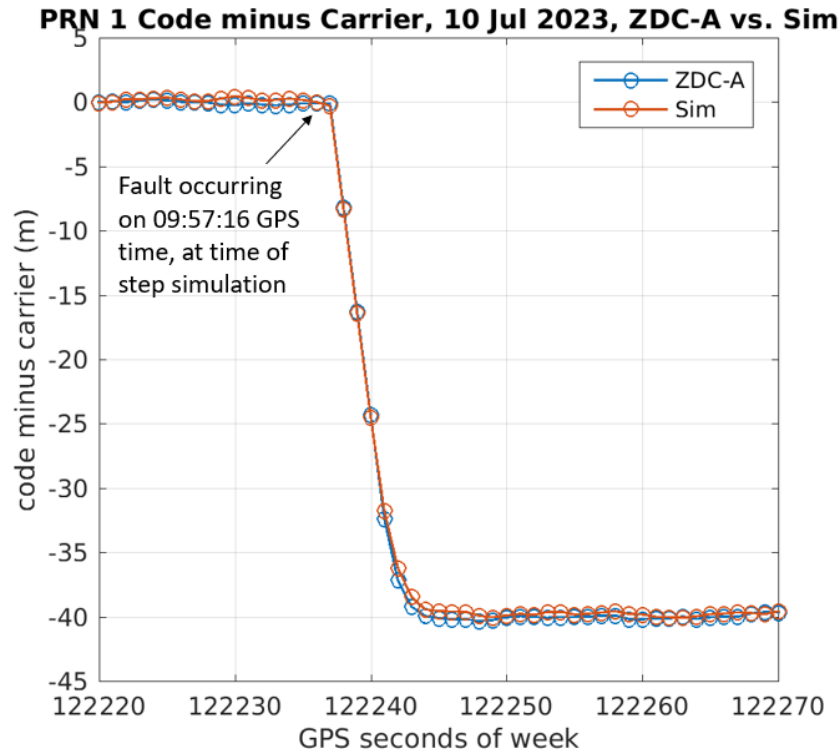
On July 10, 2023, the NovAtel G-III receivers used by the WAAS observed a rapid code phase of -40 m within roughly 6 seconds. The observed clock ramp began on 09:57:17 GPST and exceeded the fault definition only two seconds later at 09:57:19 GPST, or 09:56:59 UTC. By 09:57:24 GPST, the clock error observed by the WAAS G-III receivers settled at approximately -40 m. Five seconds later, WAAS flagged the satellite as unusable at 09:57:22 GPST. According to the Notice Advisory to Navstar Users (NANU), a message which is issued by the GPS Operations Center and the United States Coast Guard providing status updates on the health of individual GPS satellites, SVN 63 was set to the unhealthy state at 10:02:00 GPST, nearly five minutes after the fault occurred. The satellite was never set back to healthy and was decommissioned approximately one month later, on August 10, 2023.

The G-III receivers have a code-loop tracking bandwidth of 0.2 Hz and took about five seconds to settle to the final -40 m change. The carrier loops exhibited continuous tracking without a corresponding 40 m change. We suspected that the true satellite fault was an instantaneous 40 m clock jump and that the carrier loop failed to track and which affected the code loop's ability to follow immediately. To test this theory, Zeta Associates simulated a -40 m clock fault on both the code and carrier and injected this into a G-III receiver at their facility. Figure 1 shows the code minus carrier data capturing the fault behavior by the G-III receiver at the ZDC station site. As can be seen, the G-III receiver maintains lock on the signal throughout the event. Although a one second sampling rate is considered high-rate, the simulation allowed the step to be injected precisely at time of week (TOW) of 122236, or 09:57:16 GPST, and was necessary to further suggest the fault cause as an instantaneous error at this specific time. The red plot in Figure 1 is the simulated result, exhibiting a near identical match to the real event observed. Therefore, we believe that SVN 63's clock did actually change to -40 m within one second, and the carrier tracking loops failed to recognize this change which in turn prevented the code-tracking loops from immediately following this clock jump. At the time of fault, the broadcast user range accuracy (URA) was 3.4 m giving a fault definition of 15.03 m. Therefore, Figure 1 reflects a fault occurring at 09:57:19 GPST, at the first data point exceeding -15 m, but it should be noted that the fault definition in reality was exceeded at the time of the instantaneous clock step, at 09:57:16 GPST.

Figure 1: Real and simulated fault behavior on SVN 63 from the G-III receiver, provided by Zeta Associates.

In comparison to Figure 1 provided by Zeta Associates, the onset and settling error of the fault are similar in behavior. It can also be seen that the ground station receivers lose signal right when the instantaneous clock jump occurred, at 09:57:16 GPST, as described earlier in the simulation using the G-III receiver data shown in Figure 1. Because all IGS stations lost code and carrier lock between 09:57:15 GPST and 09:57:19 GPST, none were able to characterize the clock behavior over that time interval. However, all observations are consistent with the presumed sudden transition between 09:57:17 GPST and 09:57:18 GPST.

In Figure 1, it can be seen that simulating a -40 m clock jump on both the code and carrier range at 09:57:16 GPST resulted in a near identical match of the satellite performance captured by the G-III receiver. Figure 6 at 09:57:16 GPST shows a well-matched signal, aside from the accumulation drop. Figure 7 shows the decomposed I and Q correlator data for L1 at an even finer sampling rate of 100 Hz. At 09:57:15.48 GPST, there is a drop in observed power, and at 09:57:15.79 GPST, the receiver stops reporting altogether. At 09:57:16.30 GPST, the receiver begins reporting again and attempts to lock onto the received signal. Around 09:57:17.05 GPST, the signal is locked on for roughly a half of a second, until 09:57:17.60 GPST, one-tenth of a second after what is shown in Figure 7, when the receiver stops reporting altogether again. After a little over 8 s, the receiver begins reporting information with seemingly normal signal lock again at 09:57:25.90. The bottom graph in Figure 7 shows the time difference of the carrier phase, which is the difference between the current time step carrier phase measurement and the preceding carrier phase measurement. We expect there to be a small increasing or decreasing change in this value as the satellite passes over the ground receiver in its orbit, such as in the behavior shown in the bottom plot of Figure 7 at 09:57:15.00 - 09:57:15.47 GPST. After 09:57:15.48 GPST, it can be seen that the carrier phase measurement obtained is abnormal.

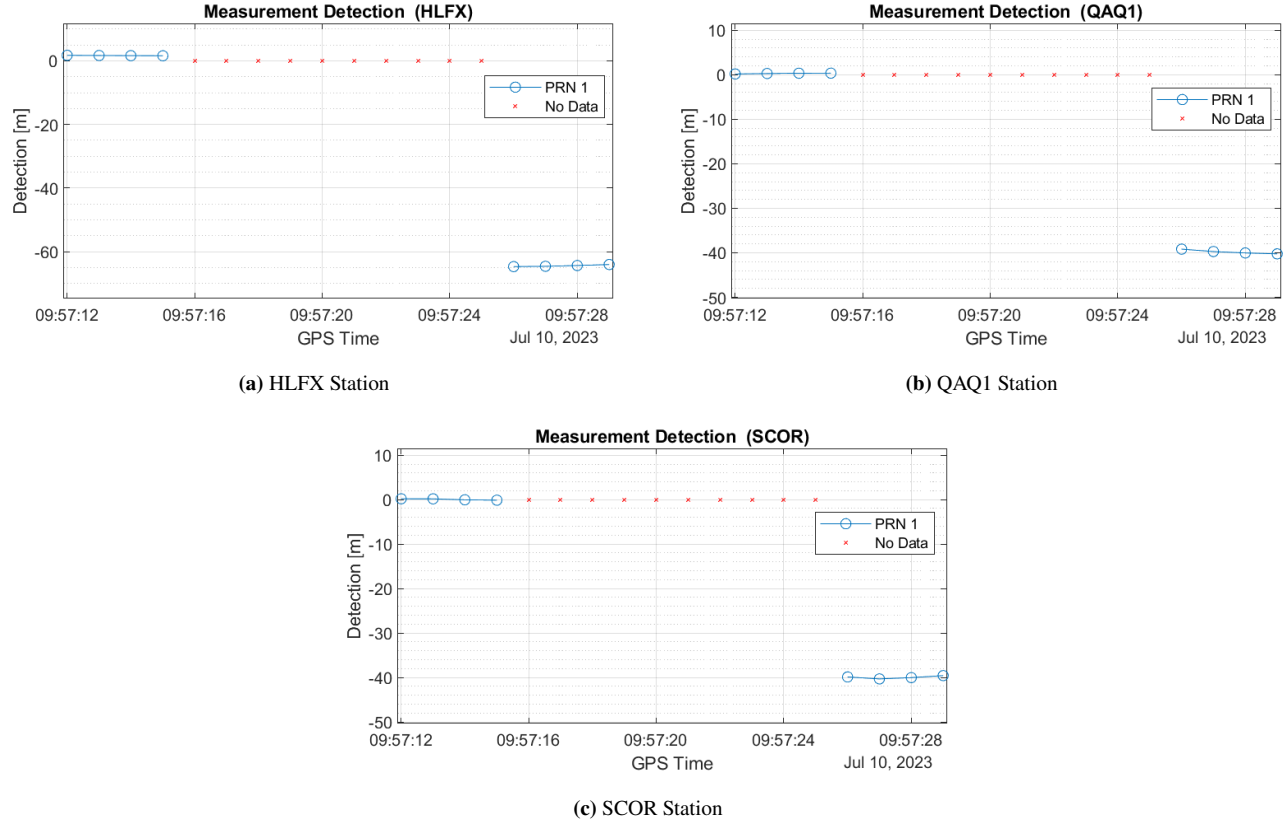
Figure 2 shows on average a better geometry of the satellite to the Trimble Alloy and JAVAD TRE_3 Delta receiver stations sampled at the time of error. Figures 3-5 are the real-time fault behavior obtained from each of these receivers sampled. The red crosses plotted represent missing data for that time step. Figure 3 shows the fault behaviors obtained by the Septentrio PolaRx5 receiver types. Although two of the three receivers sampled reach a maximum error of -40 m, results from the HLFX station show an initial error greater than -60 m at the beginning of the fault. Furthermore, the receiver stations sampled for this receiver

It can be seen through Figures 3 and 5 and more straightforward in Table 1 that receivers of the same manufacturer and model tend to perform similarly to each other. Furthermore, despite the differences observed, the onset behavior in the few seconds leading up to the fault show identical behavior across all ground station receiver types sampled. Not a single IGS ground station was able to track through the code jump, unlike the G-III receiver performance which maintained signal tracking throughout.

Figure 3: Real-time fault onset behavior of Septentrio PolaRx5 receiver types on July 10, 2023.

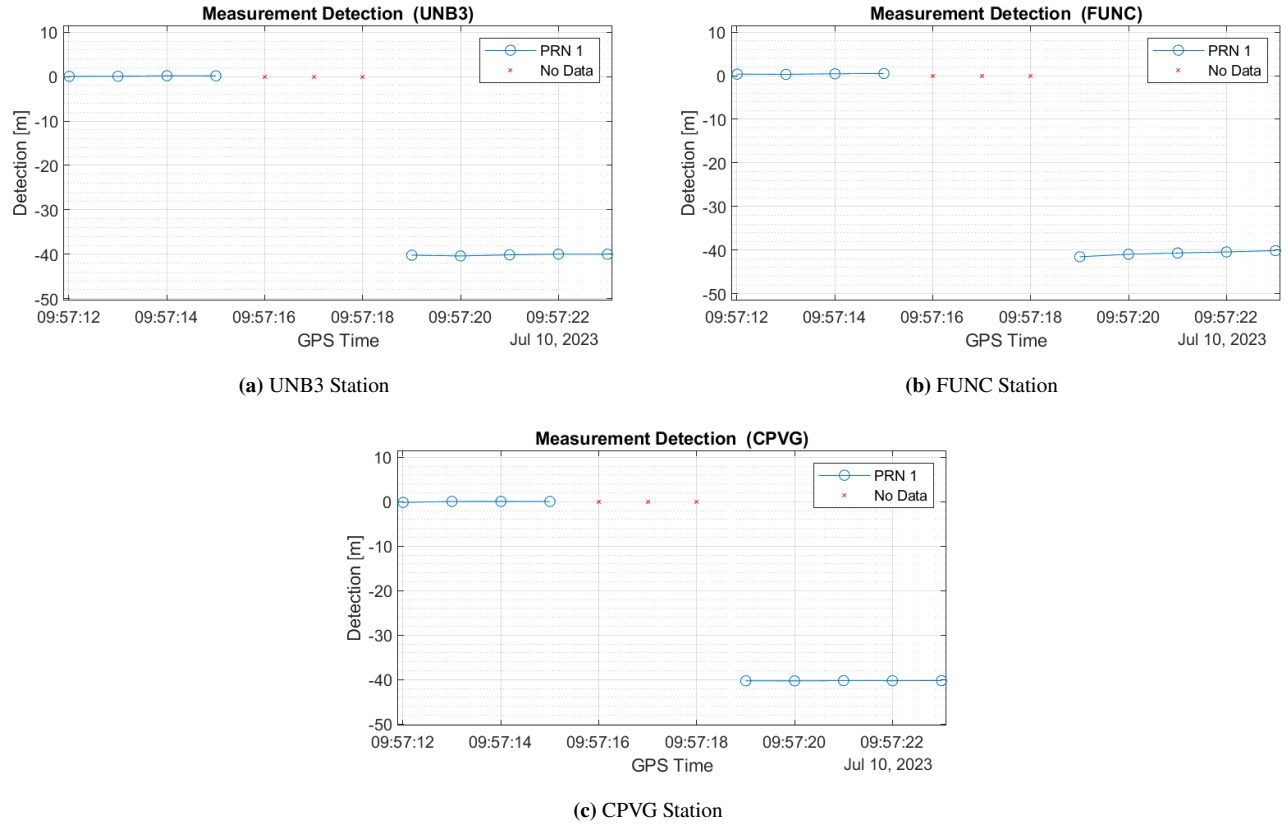
Figures 4 and 5 appear to exhibit very similar behavior in reaction to the sudden clock jump event. The duration of signal loss are all 4 seconds with the exception of the BOGT ground station receiver. The settling error of the fault are also all around -40 m for these ground receivers.

Figure 4: Real-time fault onset behavior of Trimble Alloy receiver types on July 10, 2023.

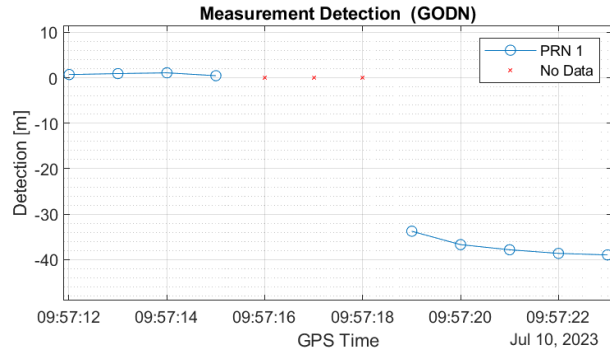
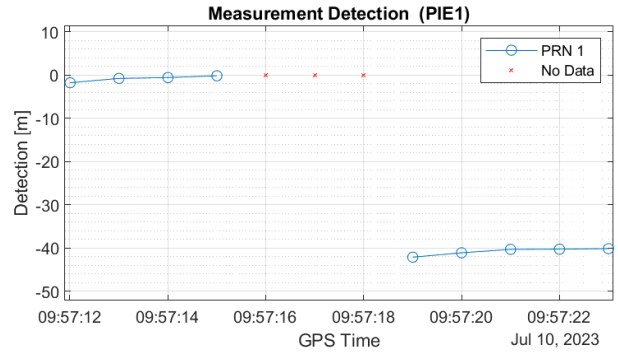
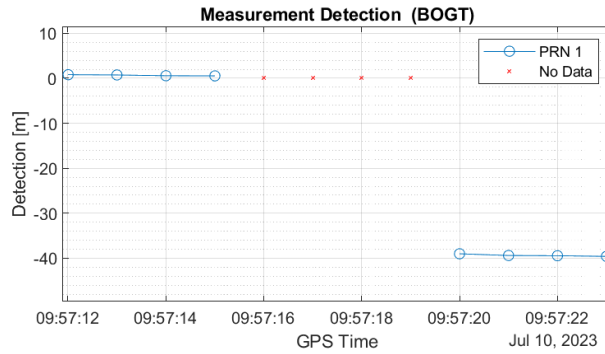
Figure 5: Real-time fault onset behavior of JAVAD TRE.3 Delta receiver types on July 10, 2023.

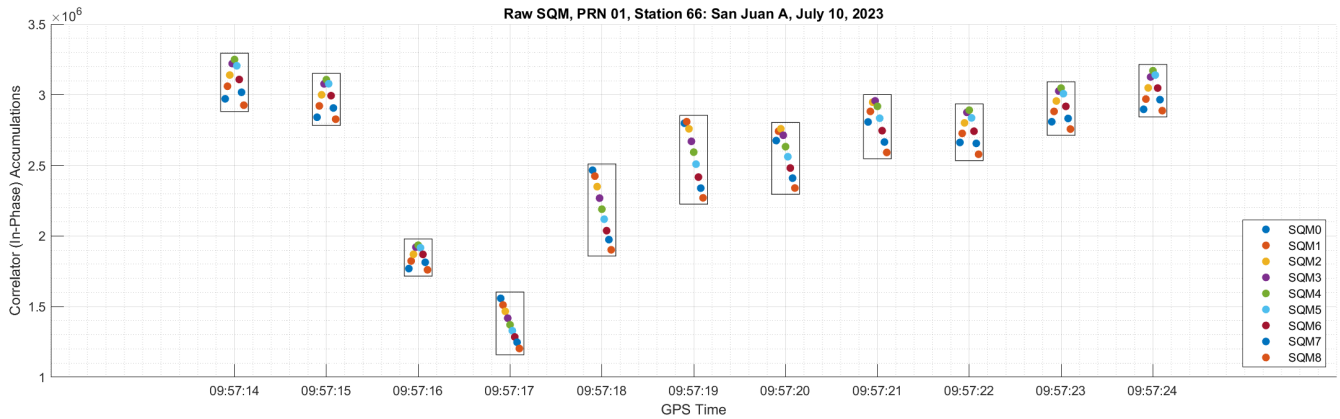
Figure 6 shows 1 Hz data of the raw correlator measurements during the few seconds before and after the apparent fault time. Note that the nine correlator taps from SQM 0 to SQM 8 are taken at the same time for each second that has passed by, but are plotted with 0.025 s offsets, with the 0 chip prompt centered at the top of the second to more clearly demonstrate the correlation peaks expected. In general, when the signal is well-matched, we expect the correlation to be lower at the “earliest” (SQM 0)

and “latest” (SQM 8) chips and the highest correlation to be found at the time-aligned prompt replica (SQM 4). This behavior is seen at times 09:57:14-16 and 09:57:22-24 GPST, although at 09:57:16 GPST there is a drop in the correlator accumulations. During 09:57:17 - 09:57:19 GPST, the received signal and the replica signal in the ground receiver are completely mismatched as can be seen by the earliest correlator taking the highest accumulations. This is consistent with a shift of the correlation peak to the left as would be caused by a -40 m clock jump. At 09:57:20-21 GPST, the receiver is already beginning to attempt locking back onto the signal.

Figure 6: Raw correlator data showing the signal mismatch at time of fault.

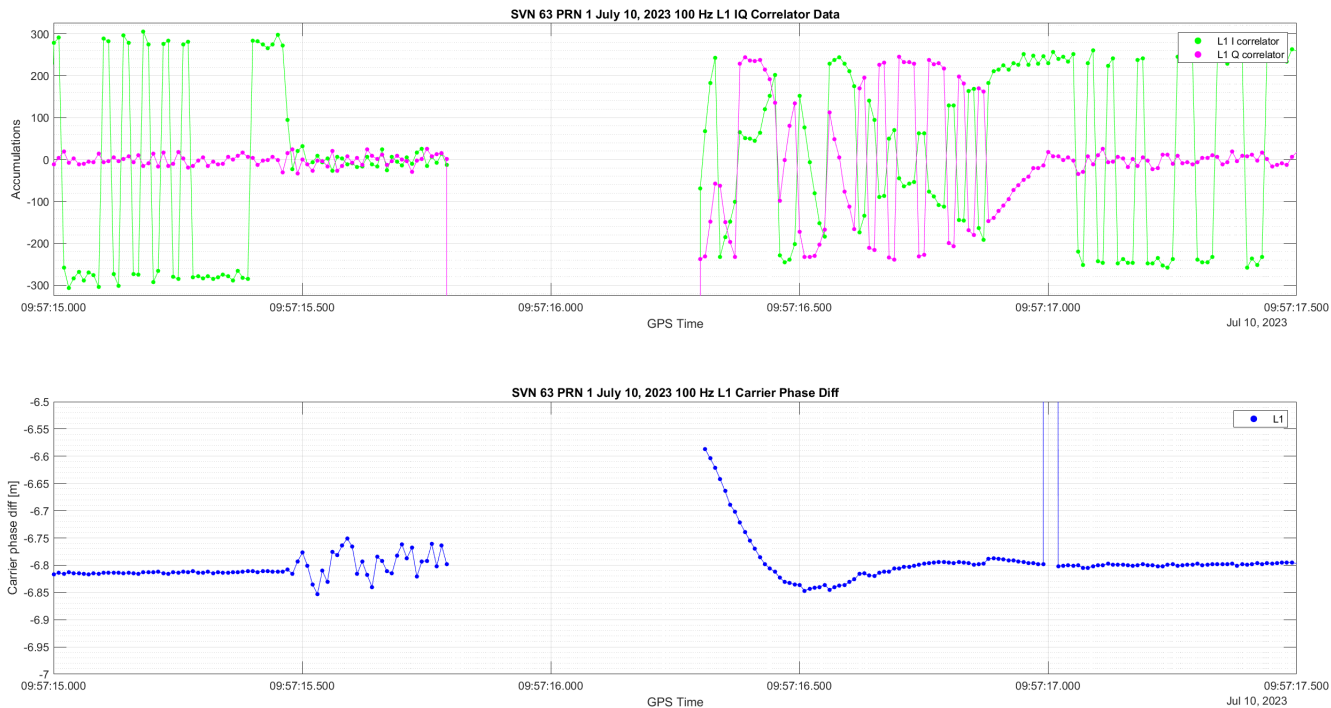
Figure 7: IQ correlator and carrier-differenced data on L1 at 100 Hz during July 10, 2023 fault onset.

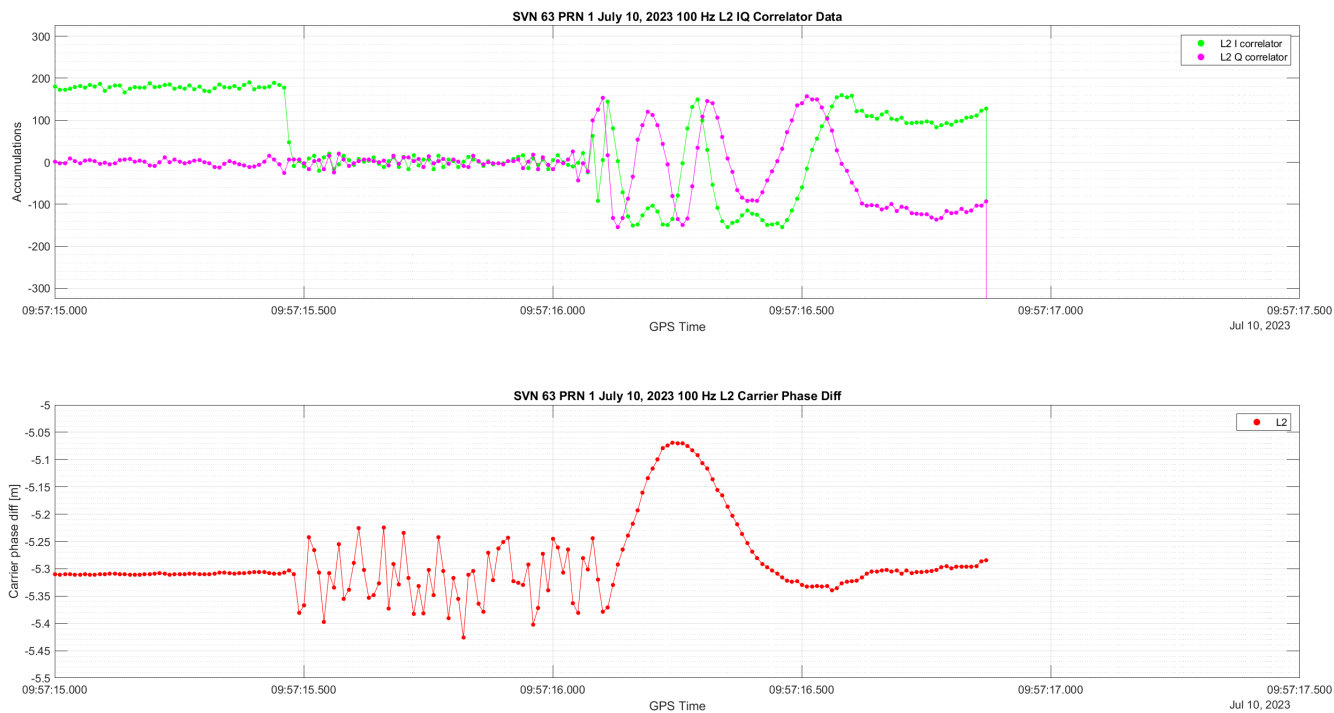
Figure 8 shows the same I and Q correlator data but for L2 from the same time period at 100 Hz. Here, the I and Q correlator on the L2 band loses power at 09:57:15.47 GPST, attempts to lock onto the signal right after 09:57:16.08 GPST before stopping reporting altogether at 09:57:16.88 GPST. The receiver begins reporting data again on the L2 band at 09:57:24.88 GPST, as seen in Figure 10.

Figure 8: IQ correlator and carrier-differenced data on L2 at 100 Hz during July 10, 2023 fault onset.

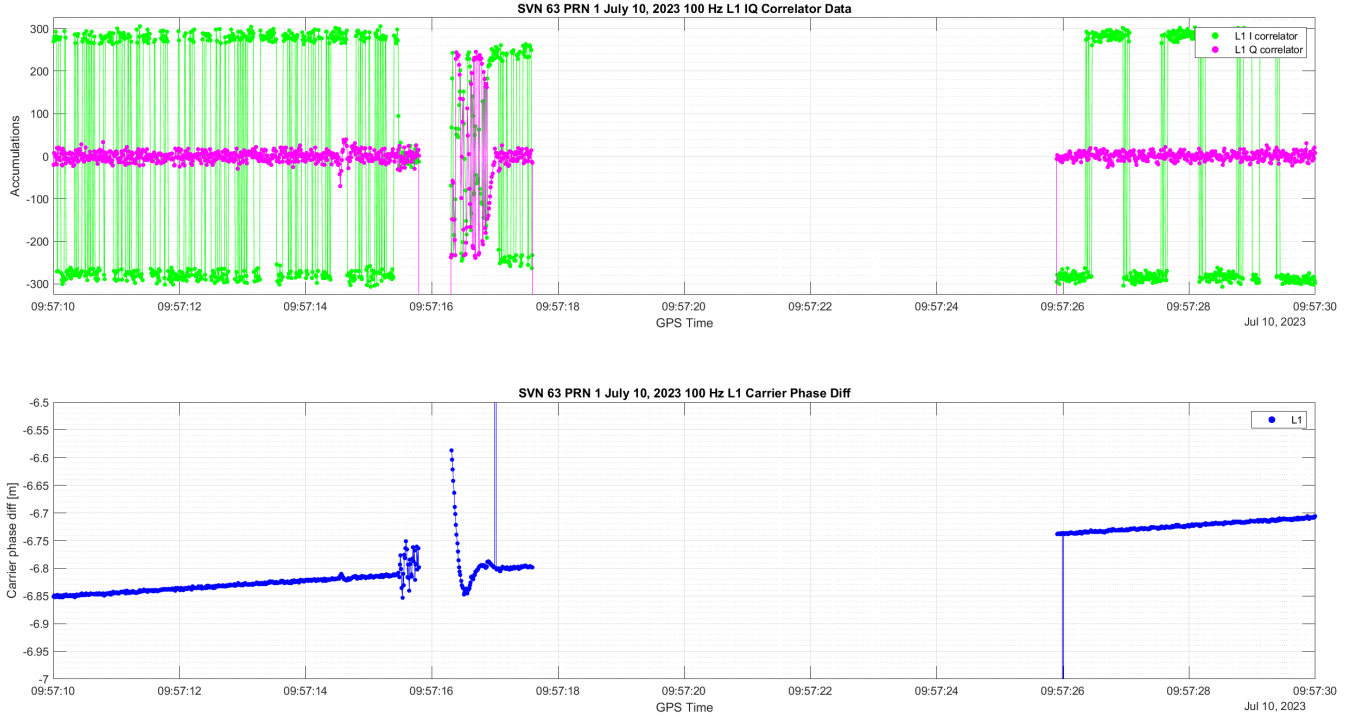
Figure 9: Zoomed out IQ correlator and carrier-differenced data on L1 at 100 Hz during July 10, 2023 fault onset.

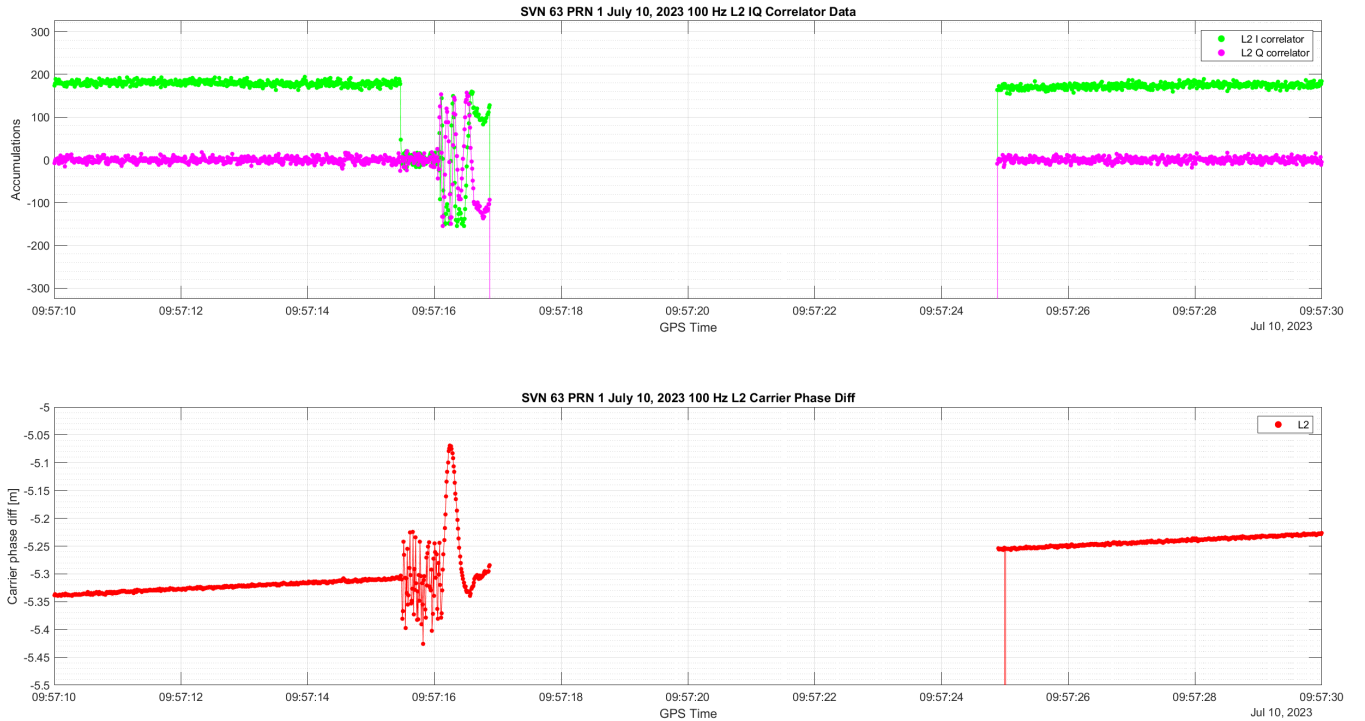
Figure 10: Zoomed out IQ correlator and carrier-differenced data on L2 at 100 Hz during July 10, 2023 fault onset.

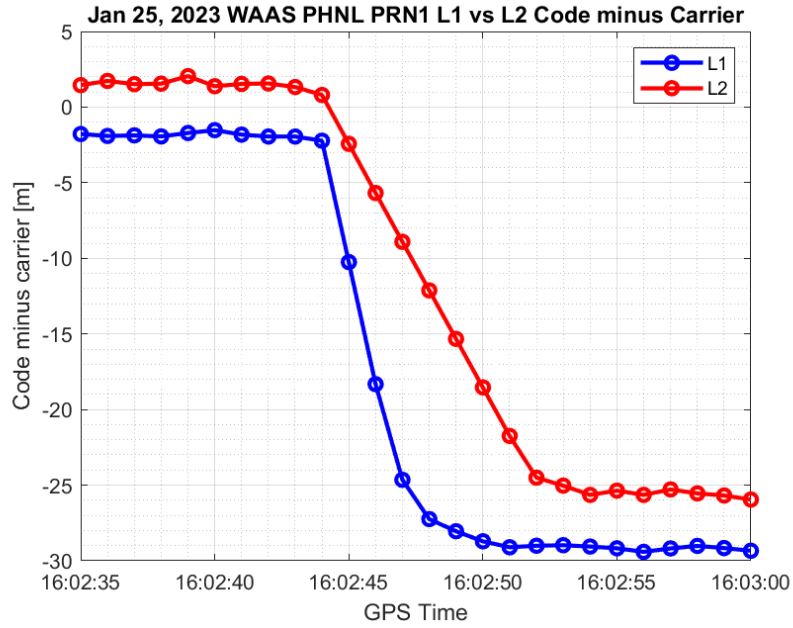
The performance of the fault which occurred on January 25, 2023 on SVN 63 captured by the WAAS NovAtel G-III receiver at the Honolulu, Hawaii station is shown in Figure 11. The blue plot shows the code minus carrier range measurements for the L1 band and the red plot shows the same for the L2 band. At 16:02:45 GPST, the code phase begins a rapid descending ramp before approaching the settling error. Taking an average of this data, we see that the settling error after the fault occurs is approximately -27 m. The lower bandwidth of the L2 signal as compared to the L1 signal may be a contributing factor for the apparent lag in reaction of the L2 data. More importantly, we see that the anomalous event has affected both the L1 and L2 signals similarly.

Figure 11: January 25, 2023 WAAS NovAtel G-III Receiver L1 and L2 data.

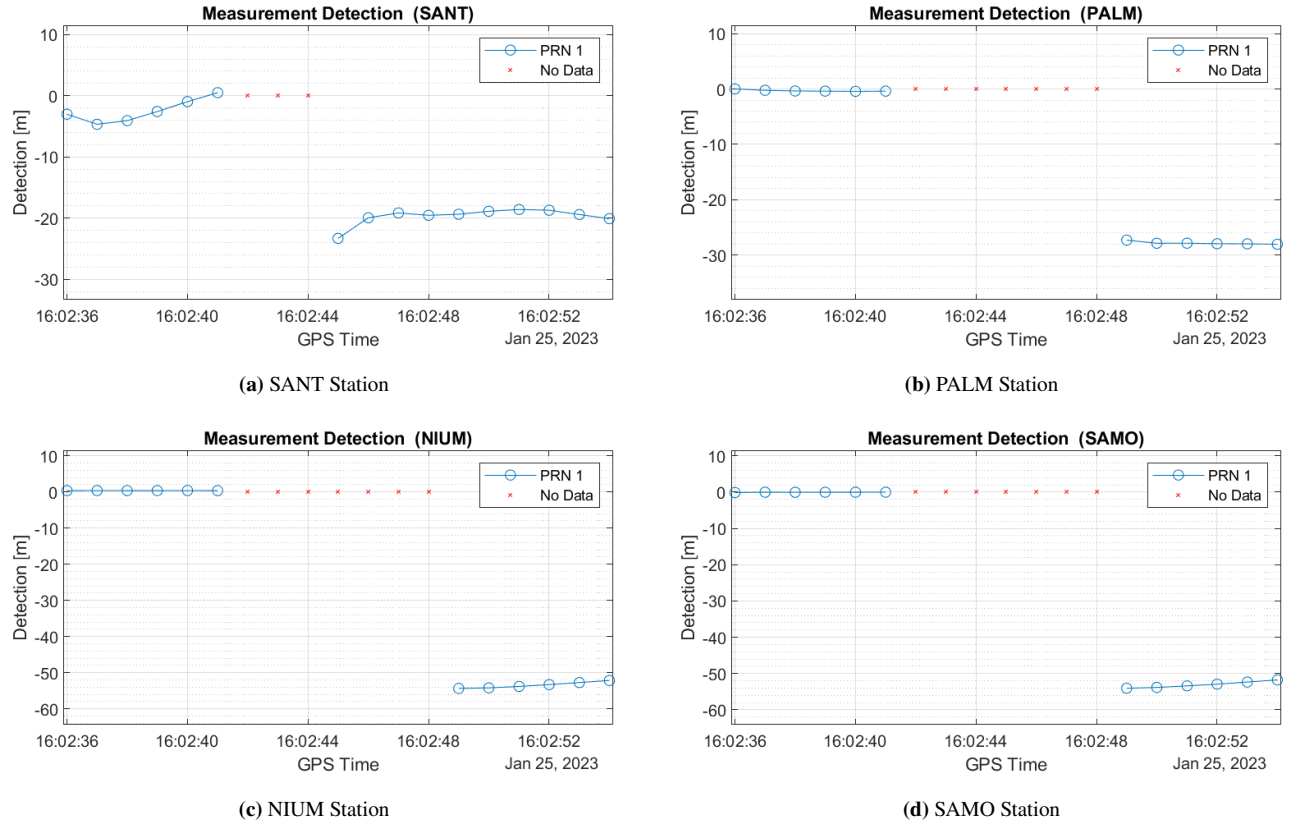
To investigate the satellite fault cause and evaluate the response by WAAS, similar to the July 10, 2023 analysis, we identify a handful of IGS stations to compare receiver performance with. Figure 12 shows the locations of these IGS ground receivers in relation to the location and footprint of SVN 63 on January 25, 2023. Due to the location of the satellite being mainly over a body of water, the IGS receivers sampled here are four Septentrio PolaRx5 receivers, three Trimble Alloy receivers, and two Trimble NETR9 receivers. All the satellites stop reporting at 16:02:41 GPST. In Figure 13, we see that for the Septentrio PolaRx5 receivers, three of the four receivers sampled experience 9 s of lack of reporting. However, two of the receivers report a settling error of approximately -53 m, with the other two receivers reporting approximately -20 and -27 m settling error after the fault.

Figure 13: Real-time fault onset behavior of Septentrio PolaRx5 receiver types on January 25, 2023.

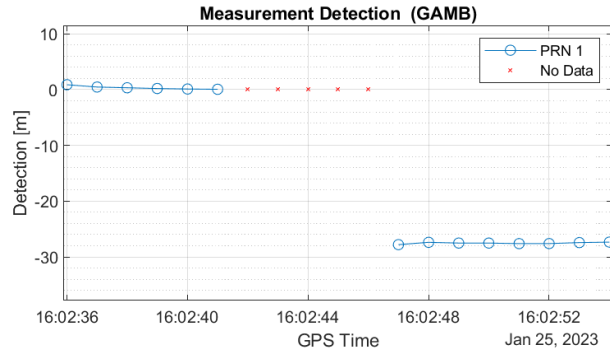
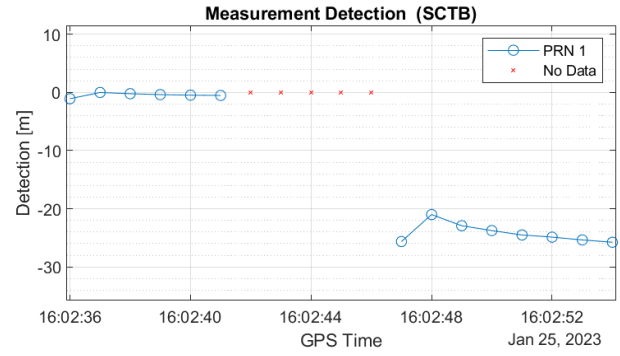
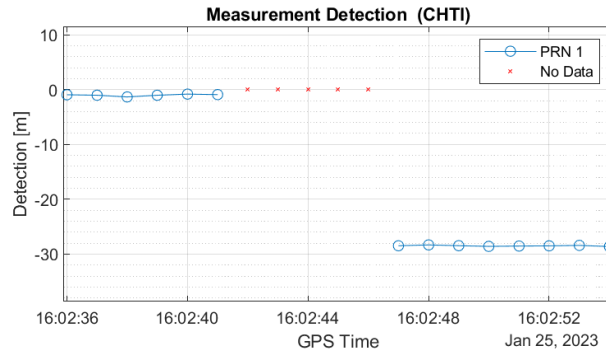
Figure 14 shows the satellite signal behavior near the time of fault on January 25, 2023 captured by the Trimble Alloy receivers.

A seven second signal reporting loss occurred and the clock error observed were all just under -30 m, similar to the observations of Figure 11.

Figure 14: Real-time fault onset behavior of Trimble Alloy receiver types on January 25, 2023.

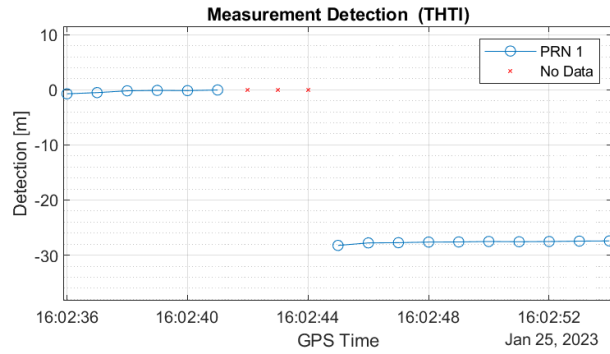
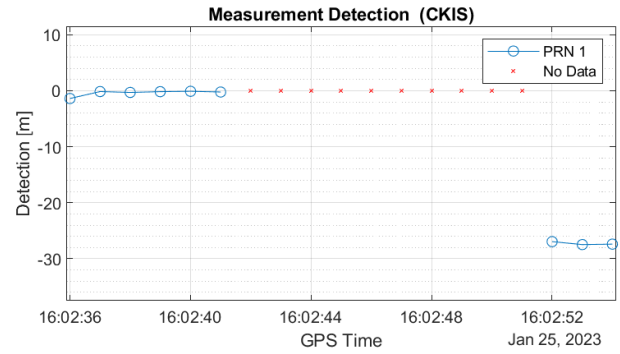
For the last receiver model sampled, the Trimble NETR9 receiver types showed a wide range of recovery times after signal loss started at 16:02:41 GPST. The IGS station in Tahiti (THTI) begins reporting again after 5 s, while the IGS station in the Cook Islands (CKIS) begins reporting after 12 s. Both stations reported just under -30 m of clock error, which is similar to the data tracked by the WAAS receiver sampled.

Figure 15: Real-time fault onset behavior of Trimble NETR9 receiver types on January 25, 2023.
