An Investigation of the Therac-25 Accidents

Nancy G. Leveson, University of Washington

Clark S. Turner, University of California, Irvine

A thorough account of the Therac-25 medical electron accelerator accidents reveals previously unknown details and suggests ways to reduce risk in the future.

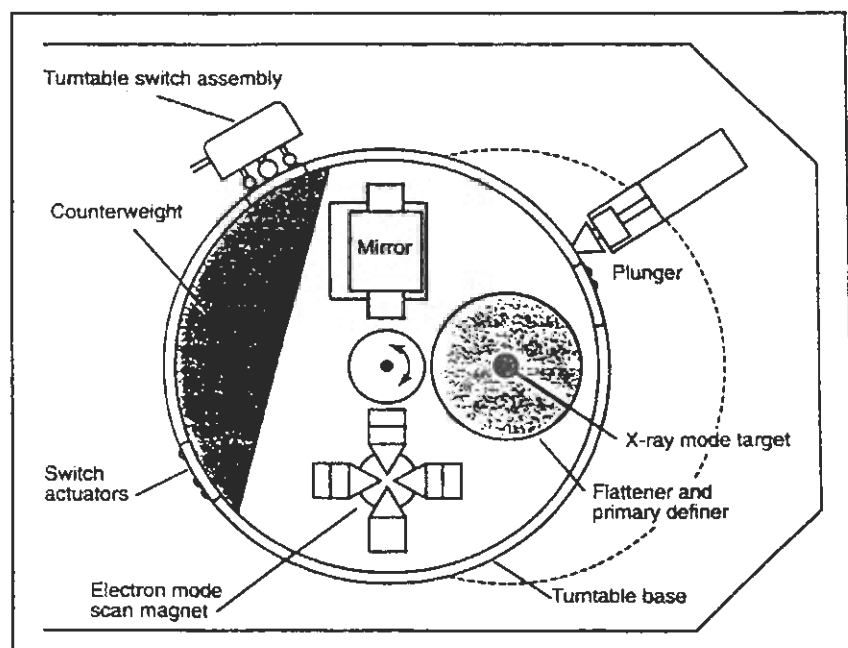
Figure B. Upper turntable assembly.

Manufacturer response. AECL could not reproduce the malfunction that had occurred, but suspected a transient failure in the microswitch used to determine turntable position. During the investigation of the accident, AECL hardwired the error conditions they assumed were necessary for the malfunction and, as a result, found some design weaknesses and potential mechanical problems involving the turntable positioning.

crosswitch codes (which could be caused by a single open-circuit fault on the switch lines) could produce an ambiguous position message for the computer.

cate turntable position that tolerated a 1-bit error: The code would still unambiguously reveal correct position with any one microswitch failure.

The modifications recommended in the Symonds report included redesigning the microswitch and changing the way the computer handled malfunction conditions. In particular, treatment was to be terminated in the event of a dose-rate malfunction, giving a treatment "suspend." This would have removed the option to proceed simply by pressing the "P" key. The report also made recommendations regarding collimator test procedures and message and command formats. A November 8, 1985 letter signed by Ernest Létourneau, M.D., director of the CRPB, asked that AECL make changes to the Therac-25 based on the Symonds report "to be in compliance with the RED Act."

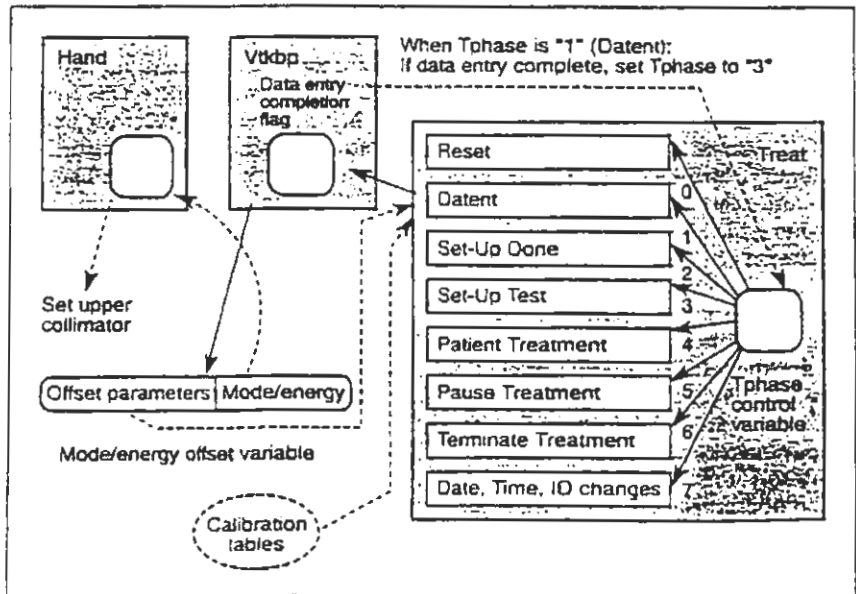
Figure 2. Tasks and subroutines in the code blamed for the Tyler accidents.

shared variable (Data-entry completion flag) to determine whether the prescription data has been entered. The keyboard handler recognizes the completion of data entry and changes the Data-entry completion variable to denote this. Once the Data-entry completion variable is set, the Datent subroutine detects the variable's change in status and changes the value of Tphase from 1 (Data Entry) to 3 (Set-Up Test). In this case, the Datent subroutine exits back to the Treat subroutine, which will reschedule itself and begin execution of the Set-Up Test subroutine. If the Data-entry completion variable has not been set, Datent leaves the value of Tphase unchanged and exits back to Treat's main line. Treat will then reschedule itself, essentially rescheduling the Datent subroutine.

Upon exit from the Magnet subroutine, the data-entry subroutine (Datent) checks the data-entry completion variable. If it indicates that data entry is complete, Datent sets Tphase to 3 and Datent is not entered again. If it is not set, Datent leaves Tphase unchanged, which means it will eventually be re-scheduled. But the data-entry completion variable only indicates that the cursor has been down to the command line, not that it is still there. A potential race condition is set up. To fix this, AECL introduced another shared variable controlled by the keyboard handler task that indicates the cursor is not positioned on the command line. If this variable is set, then prescription entry is still in progress and the value of Tphase is left unchanged.

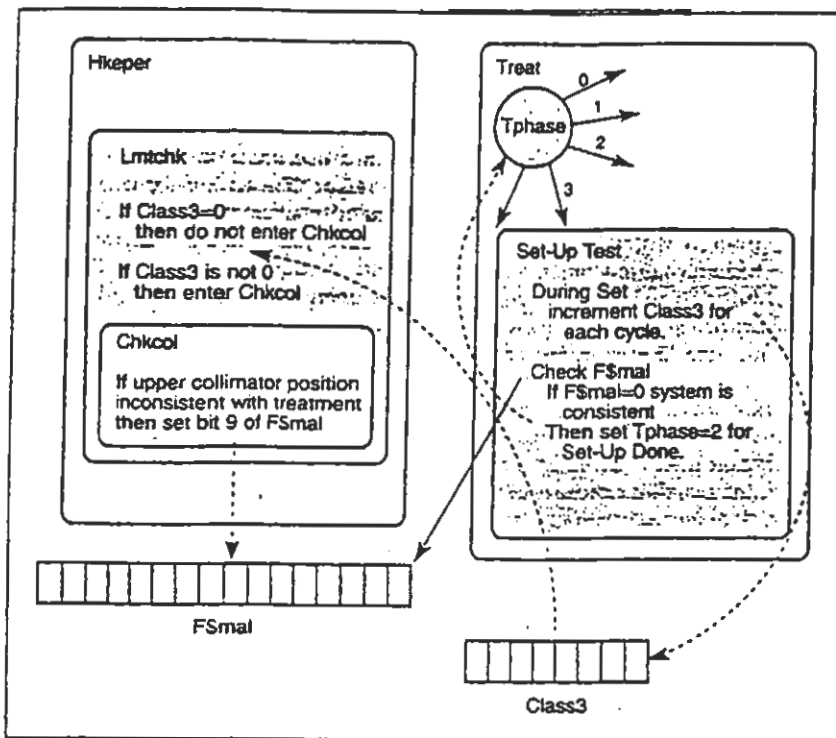
Figure 4. Yakima software flaw.

The second Yakima accident was again attributed to a type of race condition in the software — this one allowed the device to be activated in an error setting (a "failure" of a software interlock). The Tyler accidents were related to prob-

lems in the data-entry routines that allowed the code to proceed to Set-Up Test before the full prescription had been entered and acted upon. The Yakima accident involves problems encountered later in the logic after the treatment monitor Treat reaches Set-Up Test.
