# Oregon Engineering School Design

## PACIFIC VIEW DESIGN TEAM

# Structure of Presentation/ Presentation of Structure

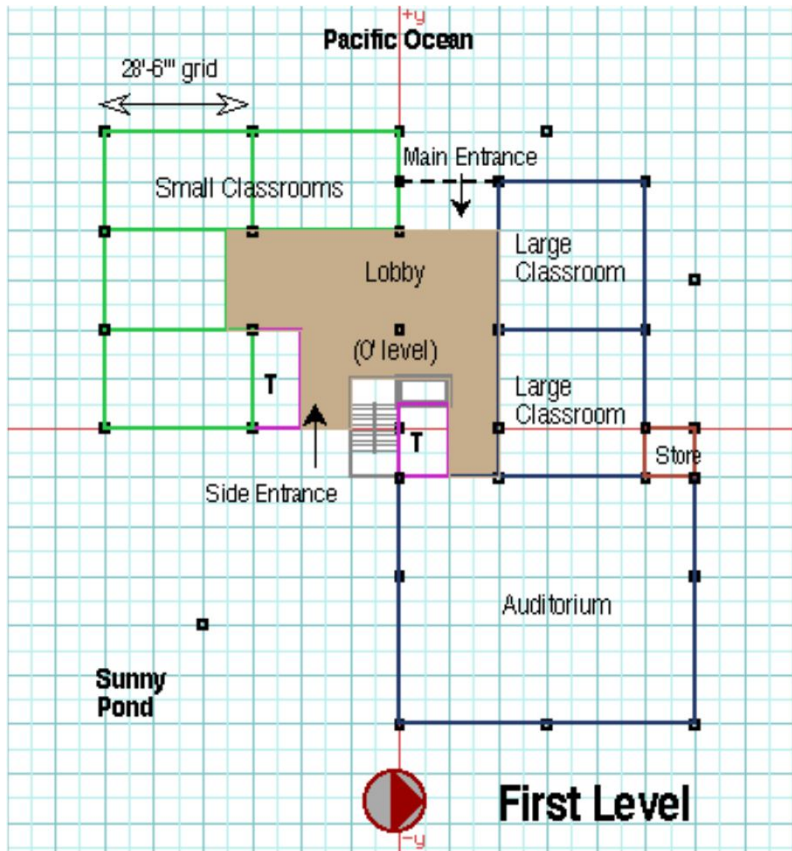
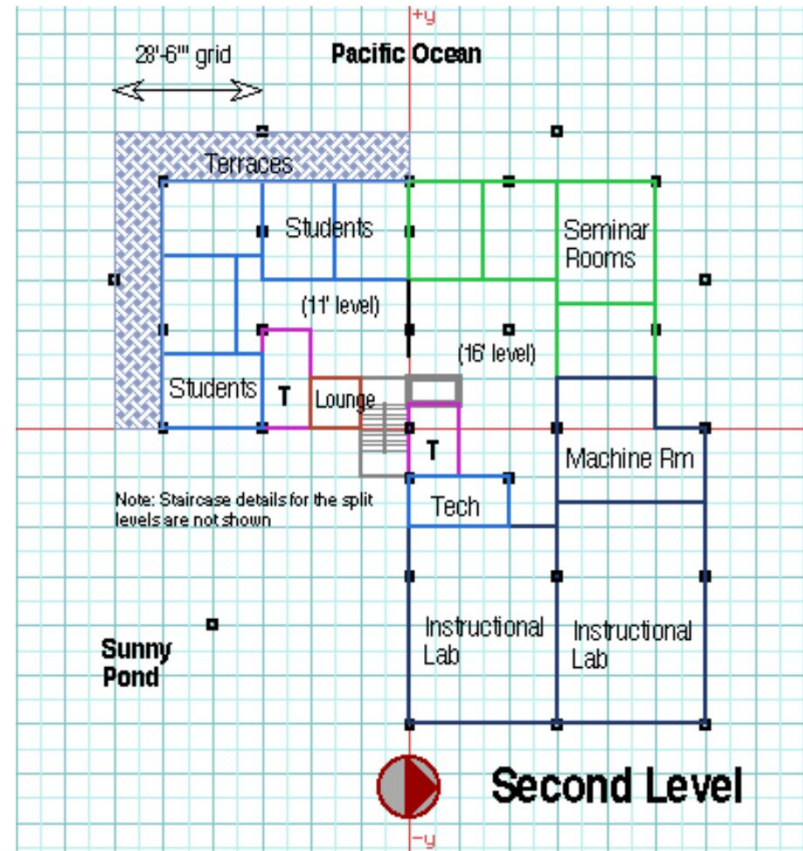
Iteration 1

- Circulation pattern was not well defined
- Overabundance of terraces
- Three seminar rooms had no natural lighting
- Toilets did not align vertically
- Too many wall offsets at third level
- Support the third floor cantilever by a vertical column going into the pond.
- Have some variation in the building section

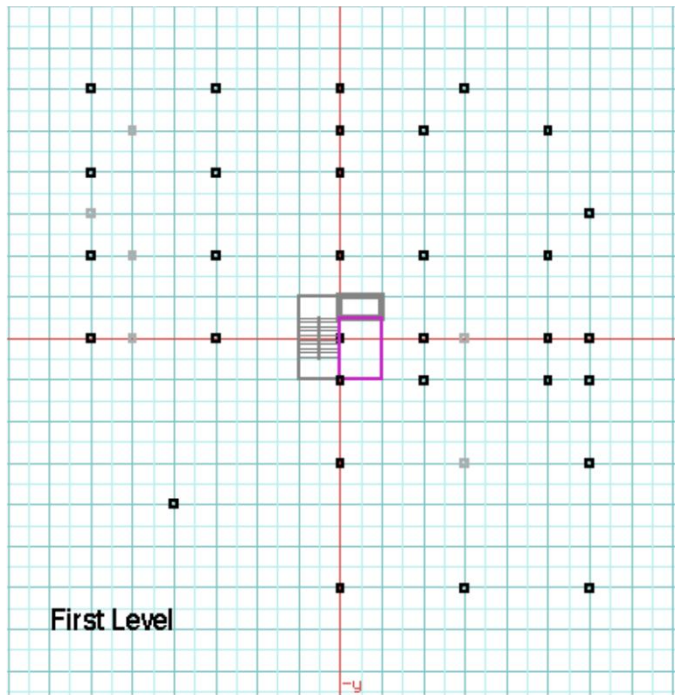
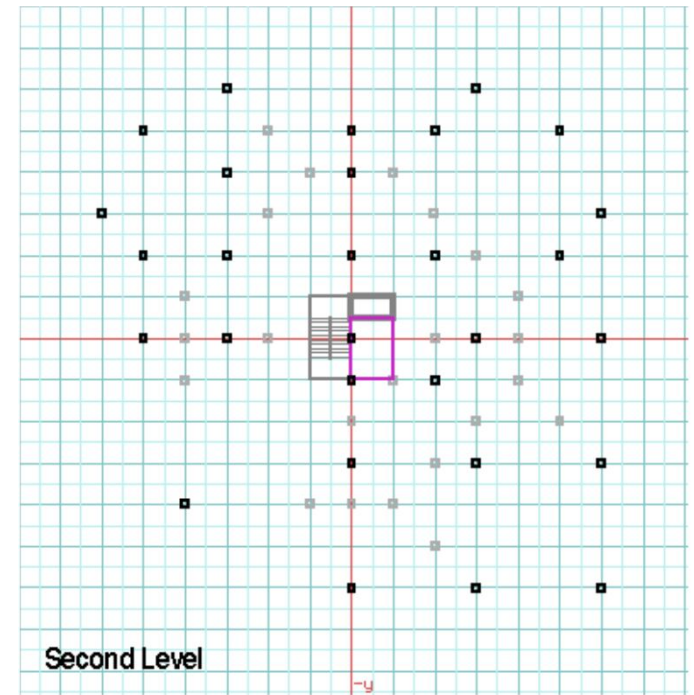
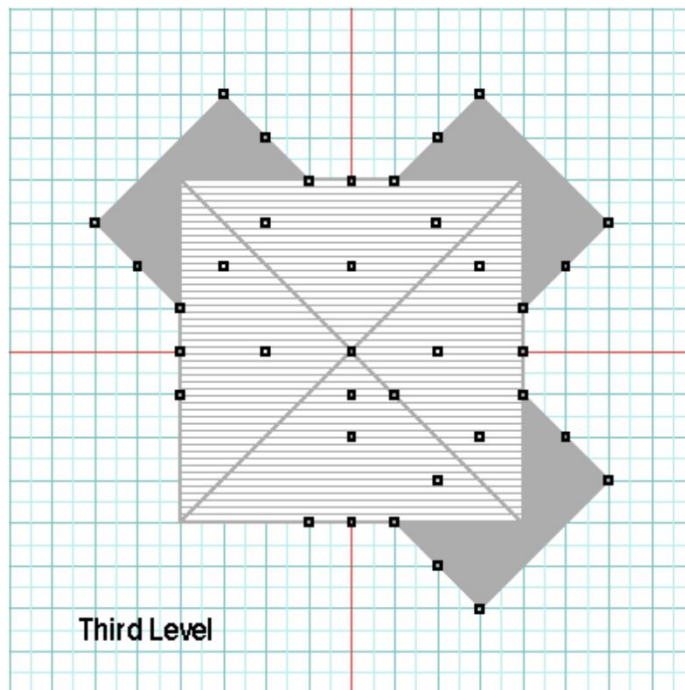
Iteration 1 - Structure

- Non uniform structural grid
- Many columns lacking vertical continuity
- 10' height for a level was insufficient for HVAC system
- Sloping roofs at the second level did not seem very well composed

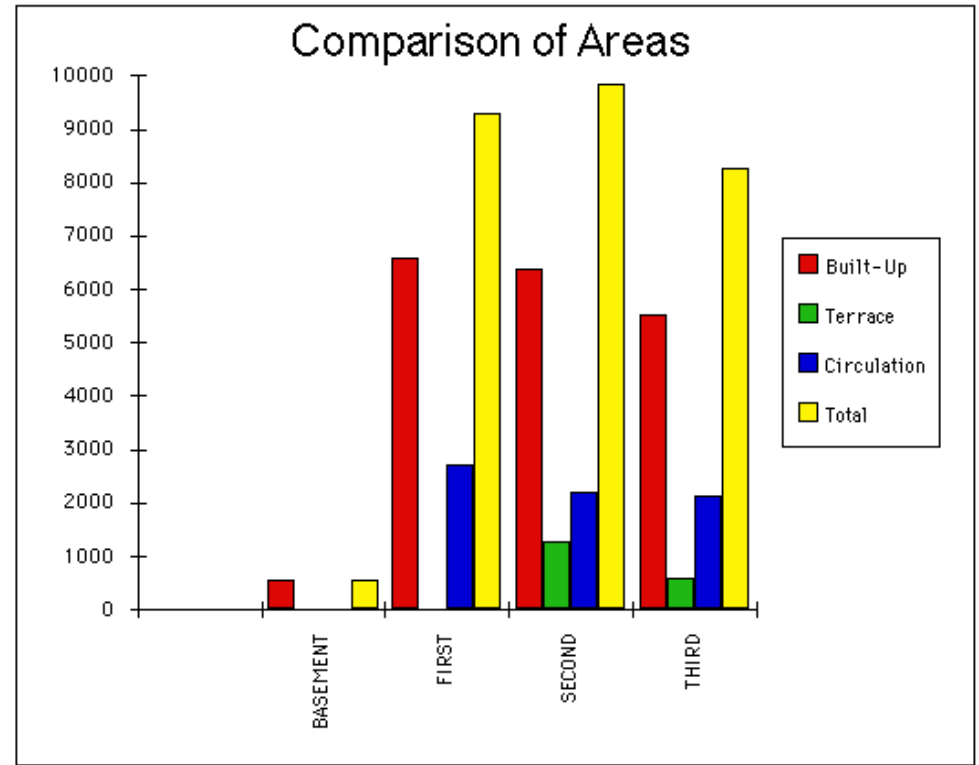
Area Comparison for Entire Building

Built-up	Terrace	Circulation	Total
18513	1849	7036	27398
