HYDROLOGIC AND WATER QUALITY CHARACTERISTICS OF
A SMALL WETLAND -
UPPER DORN CREEK WETLAND, WISCONSIN

Justin S. Rogers

A thesis submitted in partial fulfillment of
the requirements for the degree of

UNIVERSITY OF WISCONSIN-MADISON

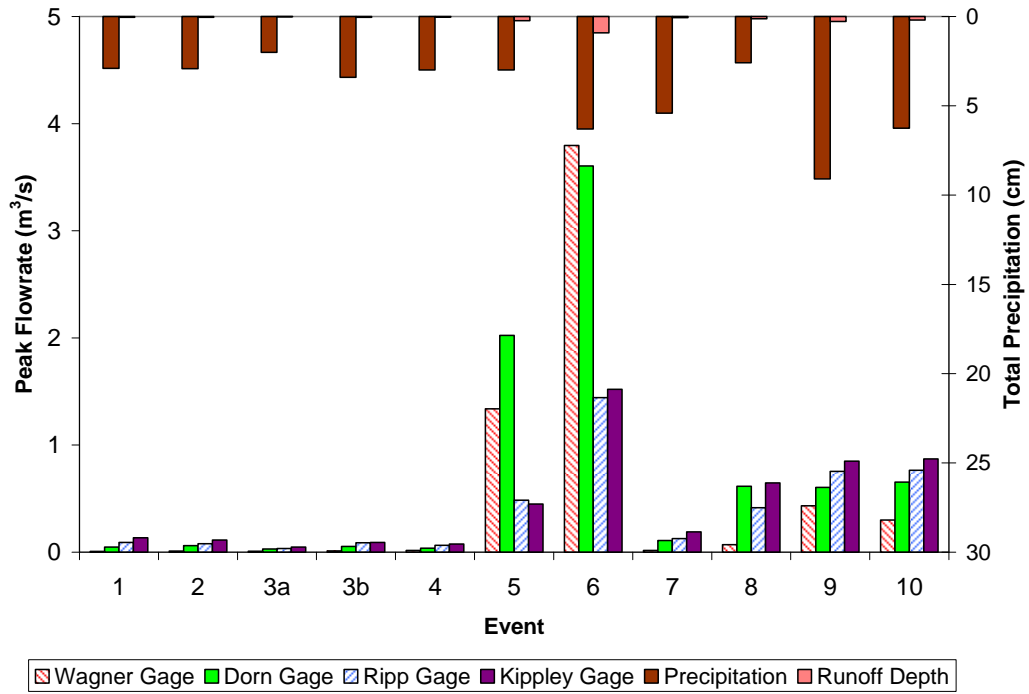
Figure 4: Peak Flowrates for 2006 Season

The following figures show the observed peak flowrates and stormflow volumes for the 11 recorded events. Figure 4 clearly shows that peak flowrates are better correlated with runoff depth than total precipitation. This is due to antecedent conditions as well as other factors, such as rainfall intensity. Events 5 and 6 were the highest recorded events in terms of both peak flowrate and storm flow volume.

For the observed record, flood peak reduction occurs for large events but not for small events (Figure 4). Large flows show a clear attenuation, while lower flowrate peaks are higher at the outlet. The transition occurs at approximately $0.65 \text{ m}^3/\text{s}$ of the incoming flowrate. Thus, near $0.65 \text{ m}^3/\text{s}$, flows enter into significant portions of the wetland, and wetland storage becomes significant. Figure 9 shows a plot of peak flowrates at the wetland inlet and outlet normalized by the total storm volume. These results indicate

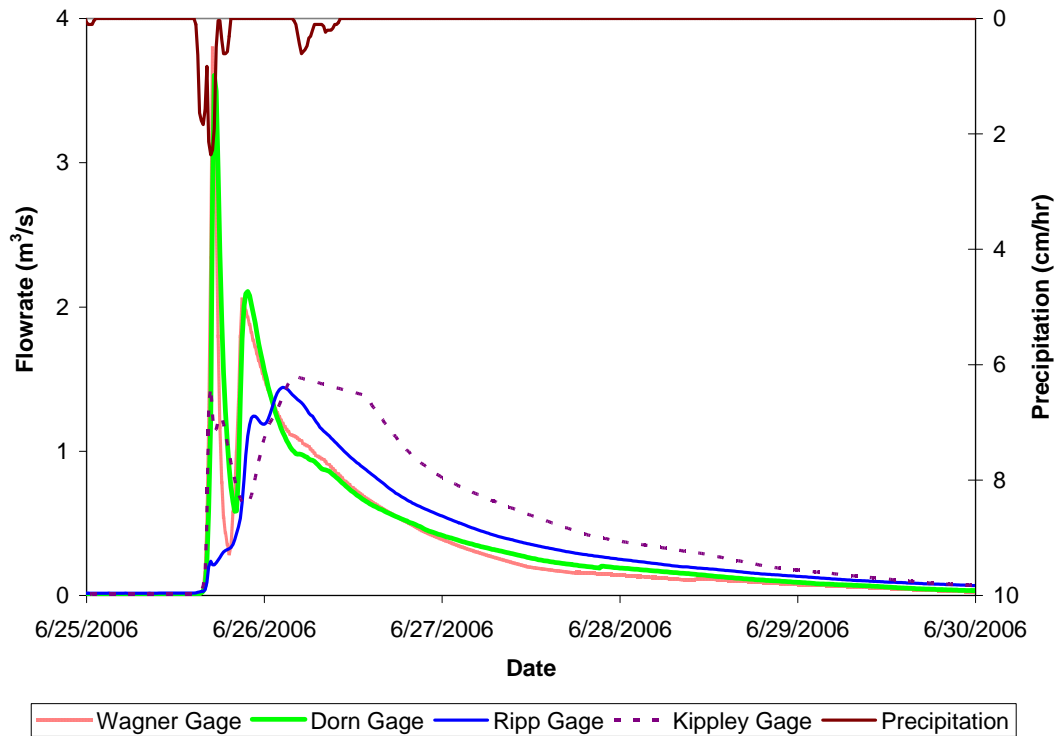
Figure 8: Largest Measured Hydrograph (Event 6)

Figure 8 shows the largest observed event for the 2006 season. This event was the result of 6.30 cm of precipitation in 4.6 hours and has an estimated recurrence interval of 1.5 years. Two peaks are seen at the Wagner Gage representing Watersheds A and B respectively. Based on analysis of the volume, Watersheds A and B (which represent 63% of the watershed area) are contributing 69% of the storm volume. Clearly,

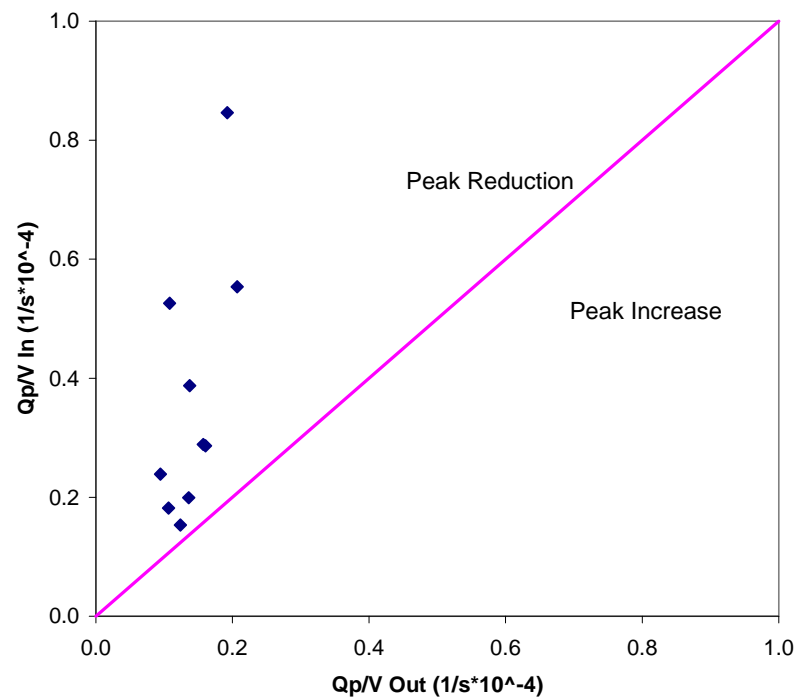
Figure 9: Incoming and Outgoing Peak Wetland Flowrates (Q_p) Normalized by Storm Volume (V) for the 2006 Season

peak reduction for all events. Inflow from the local Watershed D and the agricultural ditching in the outer areas of the wetland affect this relation. Local inflow will increase the water in the channels, causing faster conveyance through the wetland, and more inundation of the wetland by water from the inlet. Ditching allows faster conveyance of flows and forces more flow into channels. For small events (below bankfull), ditching would allow faster conveyance of flows, as water is no longer entering the wetland.

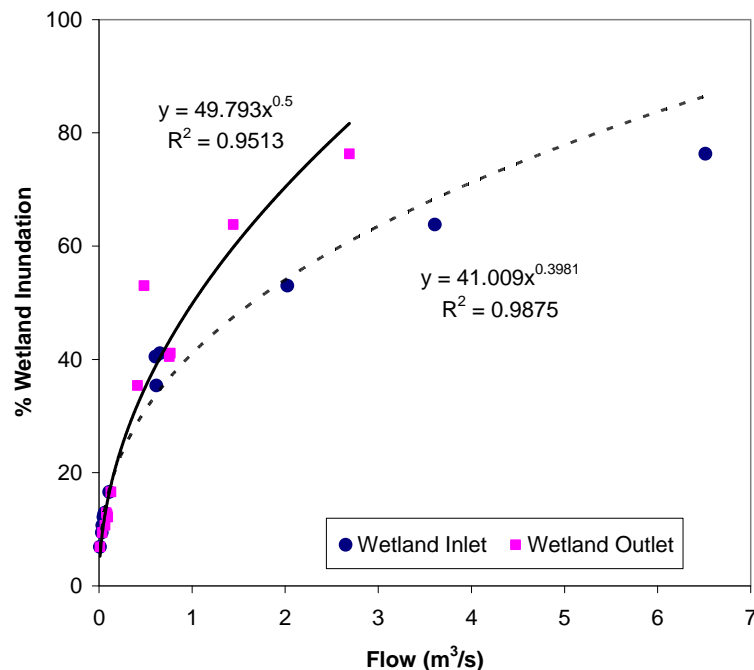
Figure 11: Percent Wetland Inundation as a Function of Incoming Flowrate and Outlet Flowrate

Downstream of the wetland, the channel is typically at bankfull conditions, and in some cases there is significant overtopping. The inundation of the wetland is 64% for this event. A 5-year event ($Q_{p\text{ in}} = 6.5 \text{ m}^3/\text{s}$, $Q_{p\text{ out}} = 2.7 \text{ m}^3/\text{s}$) was run in the HECRAS model, and gave a 76% inundation.

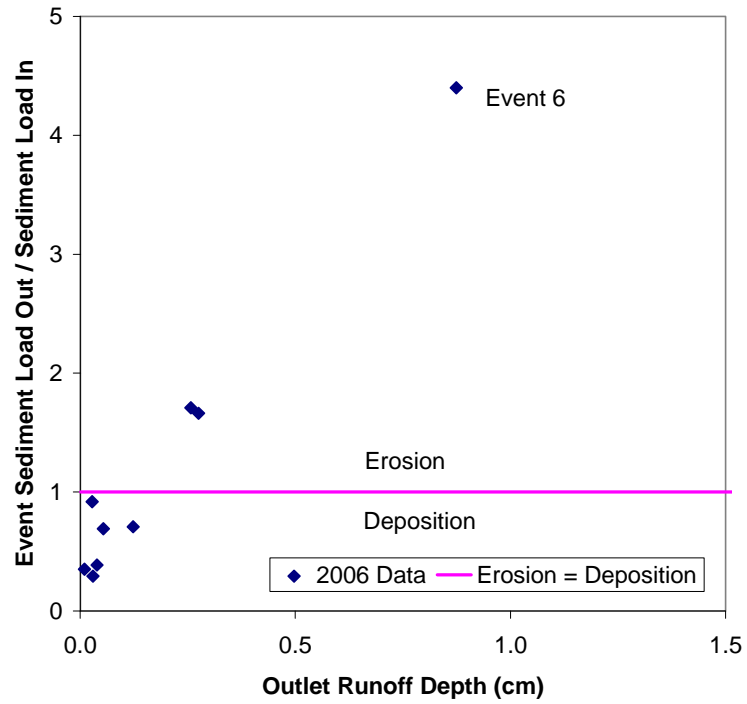
Figure 14: Wetland (Reach 3) Erosion and Deposition for 2006 Season

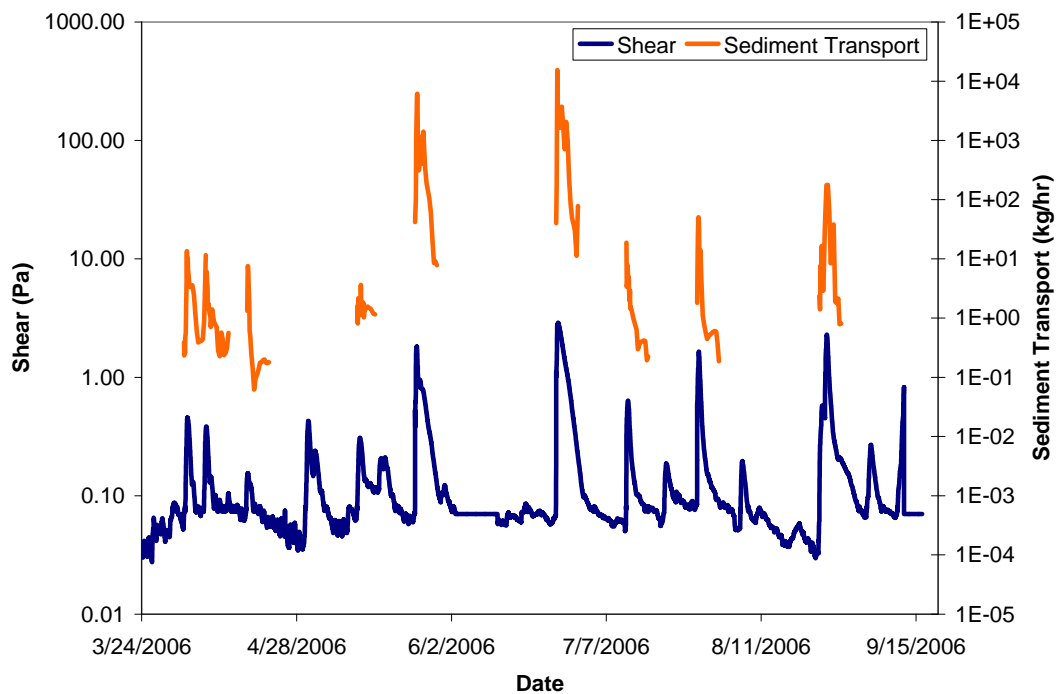
Figure 23: Bed Shear Stress and Observed Sediment at Ripp Site. Note: not all events were sampled for sediment concentration.

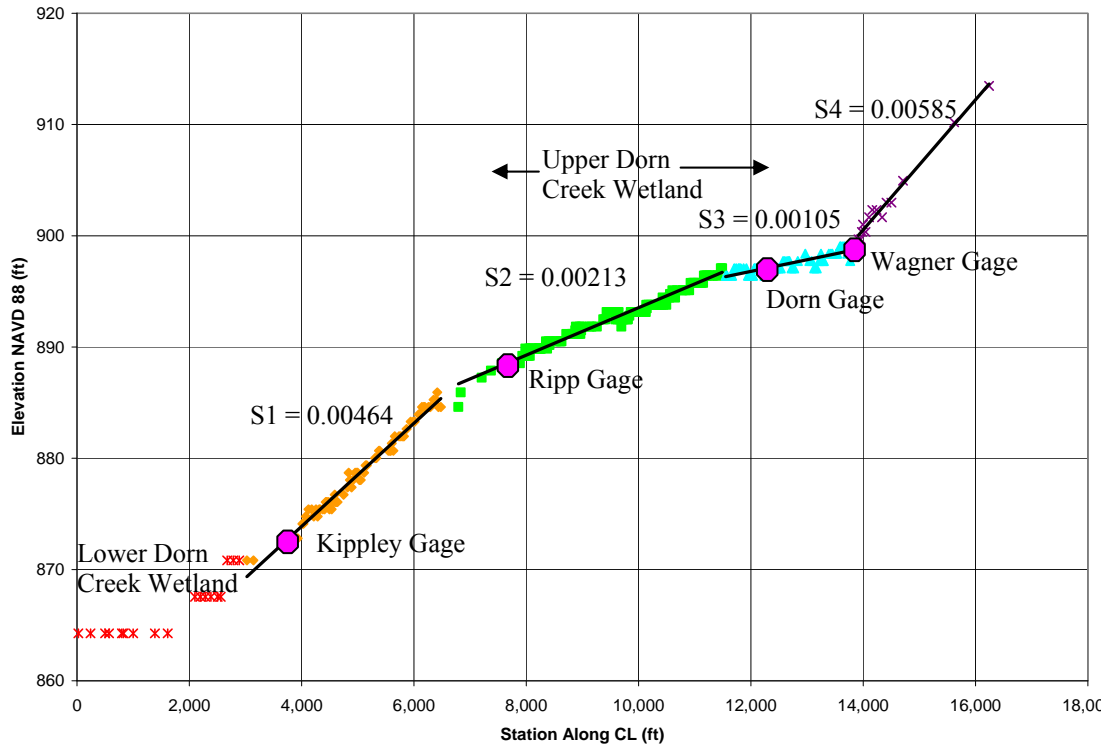
Figure 33: Dorn Creek Profile Based on LIDAR Mapping. Stationing from Confluence with Highway K

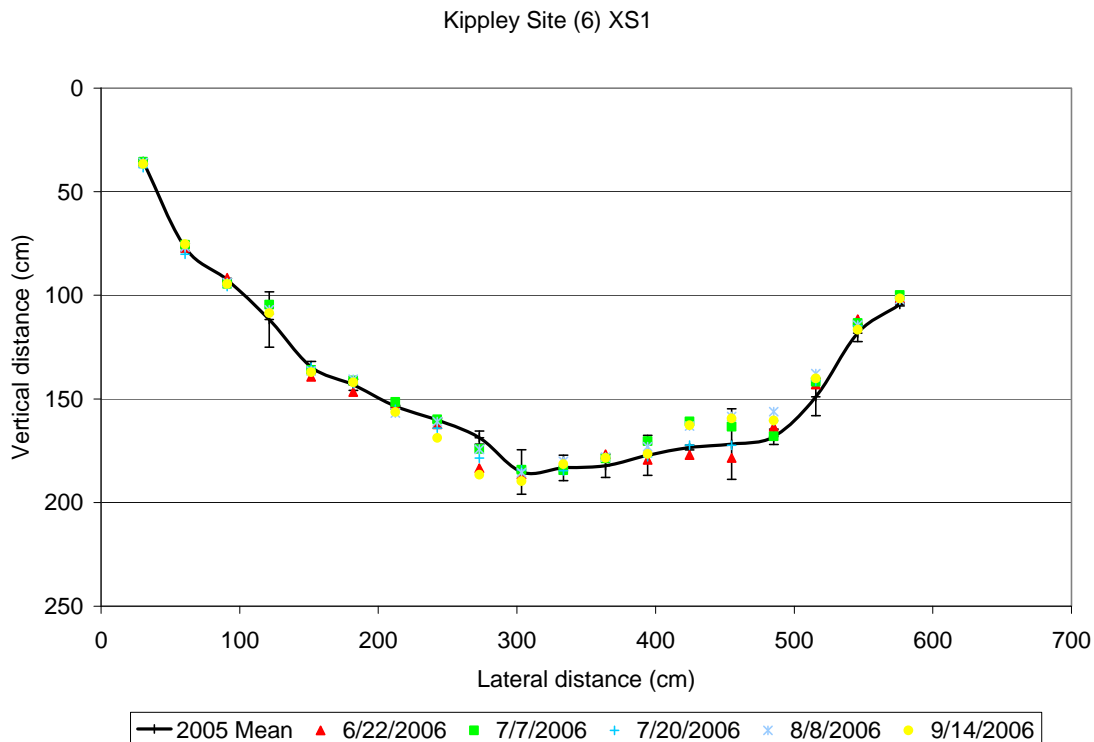
Figure 141; Bathymetry for Site 6 (Kippley) Upstream Cross Section for 2005-2006
