Characterization of Recent GPS Satellite Clock Jumps

Rebecca Wang*, Yu-Fang Lai*, Juan Blanch*, Dennis Akos**, Eric Phelts*, and Todd Walter*

**Stanford University*

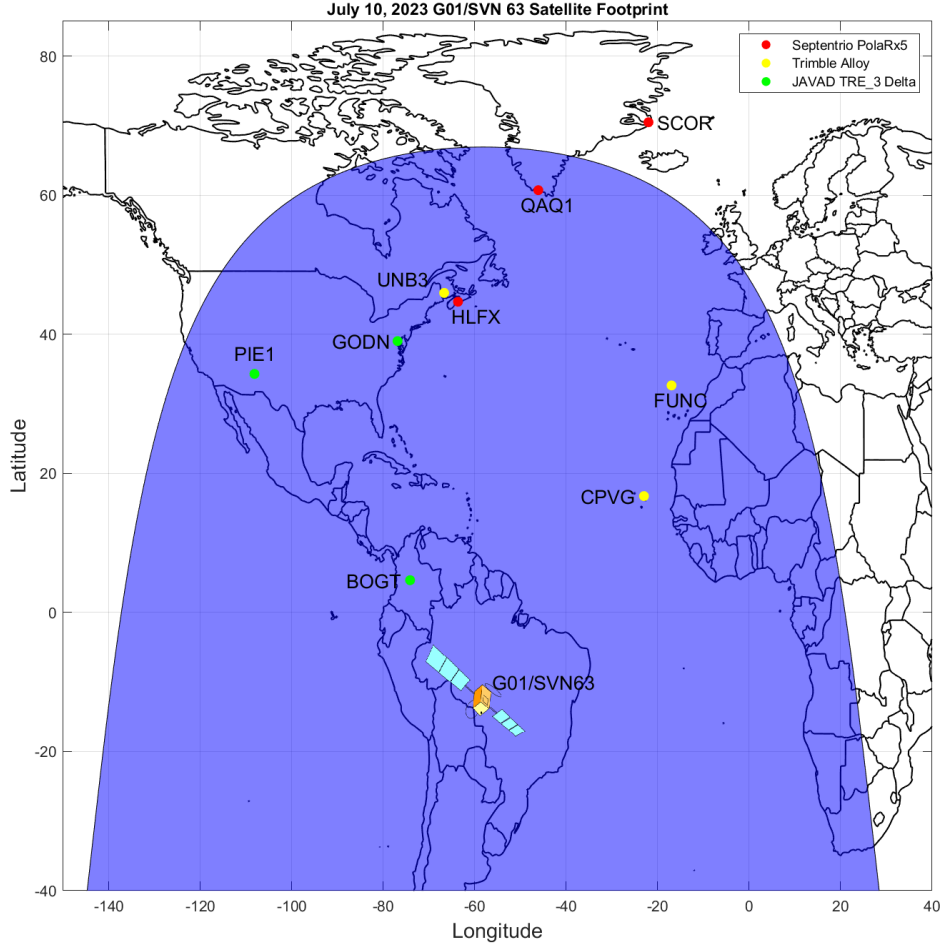
Figure 2 shows on average a better geometry of the satellite to the Trimble Alloy and JAVAD TRE_3 Delta receiver stations sampled at the time of error. Figures 3-5 are the real-time fault behavior obtained from each of these receivers sampled. The red crosses plotted represent missing data for that time step. Figure 3 shows the fault behaviors obtained by the Septentrio PolaRx5 receiver types. Although two of the three receivers sampled reach a maximum error of -40 m, results from the HLFX station show an initial error greater than -60 m at the beginning of the fault. Furthermore, the receiver stations sampled for this receiver

Figure 2: Map of IGS reference ground receivers sampled and satellite footprint of SVN 63 (GPS 1) on July 10, 2023 near time of instantaneous clock jump.

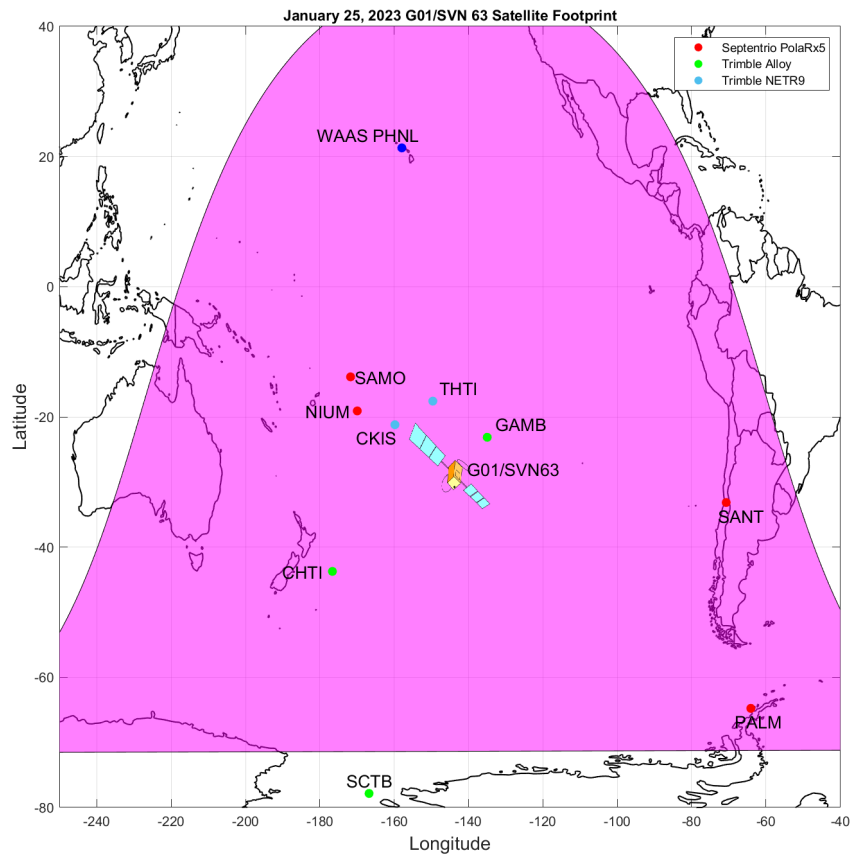
To investigate the satellite fault cause and evaluate the response by WAAS, similar to the July 10, 2023 analysis, we identify a handful of IGS stations to compare receiver performance with. Figure 12 shows the locations of these IGS ground receivers in relation to the location and footprint of SVN 63 on January 25, 2023. Due to the location of the satellite being mainly over a body of water, the IGS receivers sampled here are four Septentrio PolaRx5 receivers, three Trimble Alloy receivers, and two Trimble NETR9 receivers. All the satellites stop reporting at 16:02:41 GPST. In Figure 13, we see that for the Septentrio PolaRx5 receivers, three of the four receivers sampled experience 9 s of lack of reporting. However, two of the receivers report a settling error of approximately -53 m, with the other two receivers reporting approximately -20 and -27 m settling error after the fault.

Figure 12: Map of IGS reference ground stations sampled, WAAS station, and satellite footprint of SVN 63 (GPS 1) on January 25, 2023 near time of fault.
